**Inspection Notes of C.D.Kumar, SEO, Dharwad**

Name of The Industry visited	<b>M/s. Coramandal Sugars Ltd, (Formerly ICL Sugars Limited), Makavalli village, KR Pet Taluk, Mandya District</b>
Date of Visit	17.02.2017
Officers Accompanied	K.M.Lingaraju, SEO K.L.Savitha, RO
Person Contacted	C.Pavankumar – VP Ramakrishna, AGM-Engg

**Sub: Random inspection of organization identified based on computerized risk assessment**

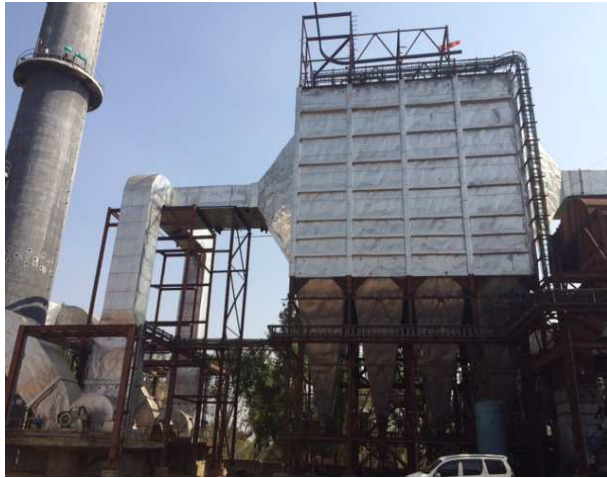
**ESP for New Boiler**

- New Boiler of 140TPH has been installed with four field ESP followed by a chimney of height 90 Mts AGL and the same has been put into operation during the season. Two old boilers of 45TPH are kept idle and the planned to scrap these old boilers. All the three Boilers were not in operation during visit. For new Boiler online emission monitoring system has been installed (though it is not mandatory for sugar units as per CPCB directions) and the same is not connected to CPCB server. Also during visit the industry representative failed to demonstrate the operation of this online emission monitoring system. They were advised to set right the system and to connect the monitoring data to CPCB server before commissioning of Boiler.

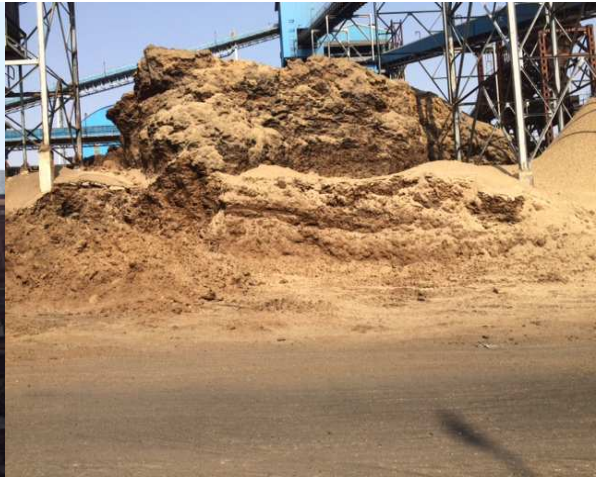
**open dumping of Bagasse**

- Haphazard dumping of scrap, poor internal roads, open dumping of small quantity of press mud besides poor handling system, dumping of bagasse noticed. The industry has to take immediate action to address these issues and to adopt best practices to prevent/control fugitive emissions besides to improve environmental conditions within the premises.

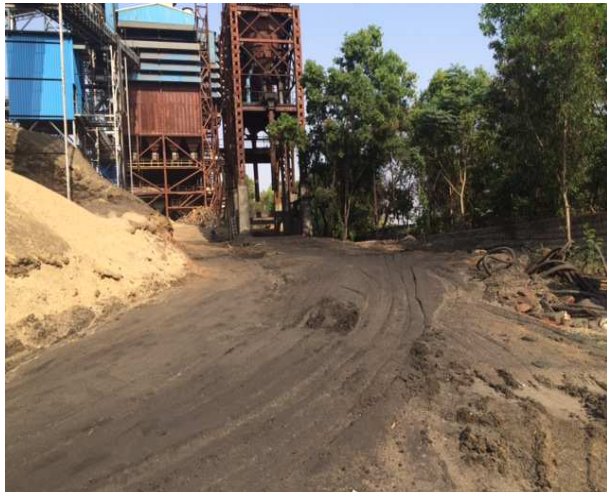
**Deposition of dust**

- Two silos are provided for collection of Fly ash and Bottom ash separately and about 3200MT of ash generated during the season. During discussions the VP informed that fly ash has been given to farmers on request and to M/s Hima Enterprises where as bottom ash is used for land filling. Lot of ash deposits noticed near ESP and in silos area leading to fugitive emissions which indicates poor ash handling. The representatives were advised to explore the possibility of mixing the ash with Press Mud (about 11,924 MT generated during the current season) to avoid fugitive emissions and to submit detailed ash management plan immediately.

- About 300 MT of coal (ancillary fuel) is stocked in closed shed and coal dust deposits noticed near coal mill and coal handling area noticed.

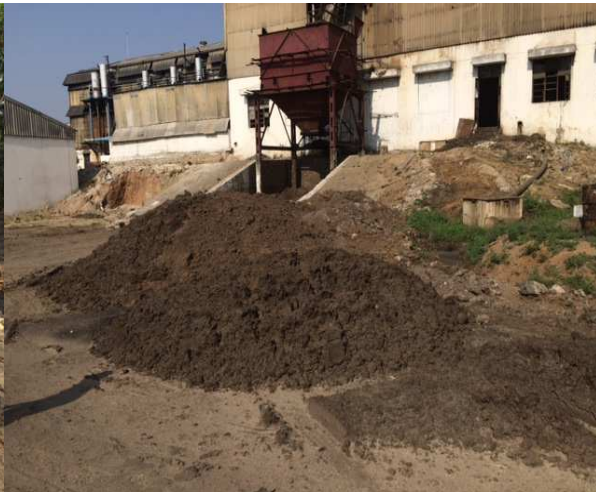
**Open dumping of Press mud ↑**

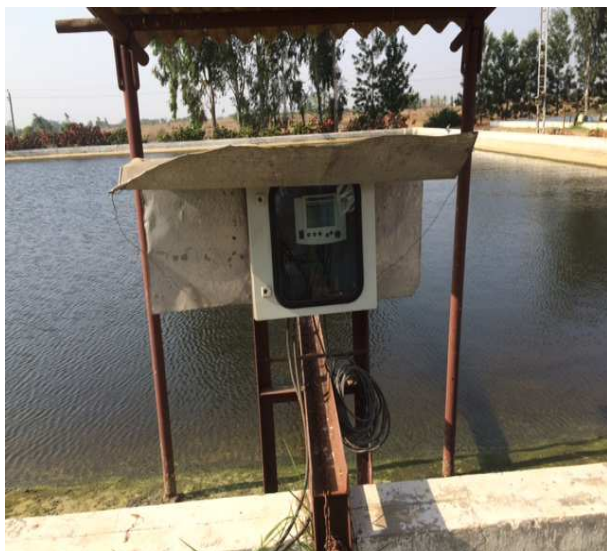
**Online monitoring system**

- The industry has provided treatment system for the treatment of trade effluents and the same was in operation during visit. On-line effluents monitoring facility to check quality of treated effluents is provided and connected to CPCB server. The on-line monitoring system was in operation reading noticed are PH-7.49, BOD-4.1, COD-39.3, TSS-6.0, Temp-25.3 and flow 0.2 M3/hr. Poor housekeeping near ETP area and spar pond area noticed.

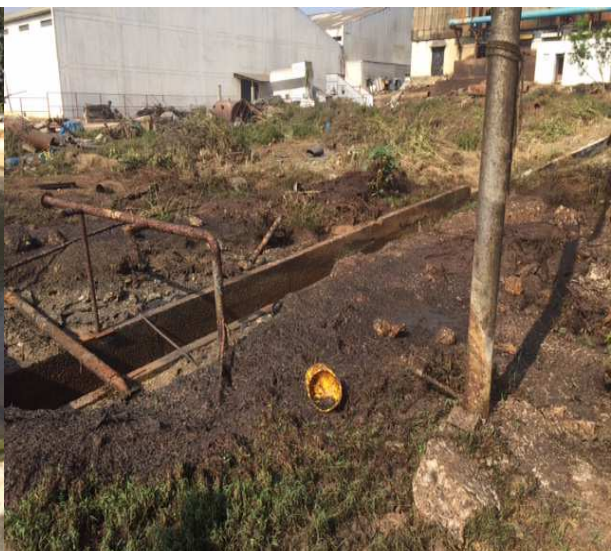
**Effluents carrying drains**
